Inspection Report

Property Address:
123 Nice Street
Asheville, NC 28801

HomeBuyers Inspection HBI

Date: 12/9/2005	Time: 10:09 AM	Report ID: sample1
Property: 123 Nice Street Asheville, NC 28801	Customer: Cameron Spears	Real Estate Professional: Steffan Buchanan Buck Realty

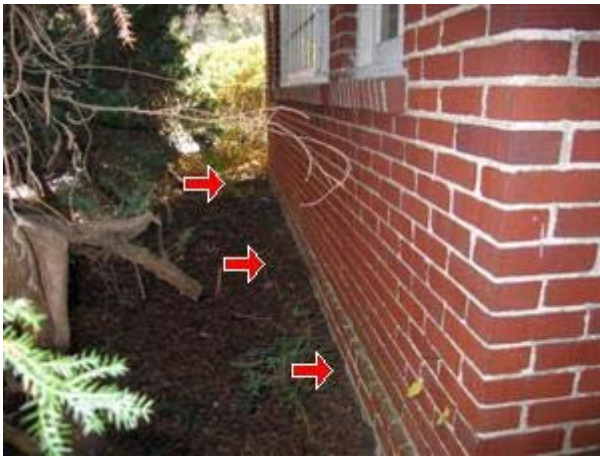
2.0 Picture 1

2.0 The Brick siding at the left side (facing front) is loose, and missing mortar. Further deterioration can occur if not corrected. A qualified contractor should inspect and repair as needed.

The Brick siding at the left side (facing front) is loose, and missing mortar. Further deterioration can occur if not corrected. A qualified contractor should inspect and repair as needed.

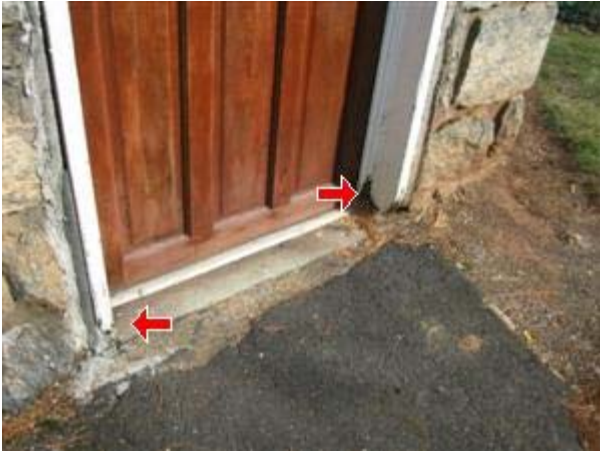
2.1 Picture 1

2.1 The main entry door at rear of home are deteriorated at bottom of jamb (s). Further deterioration may occur if not repaired. A qualified contractor should inspect and repair as needed.

The main entry door at rear of home are deteriorated at bottom of jamb (s). Further deterioration may occur if not repaired. A qualified contractor should inspect and repair as needed.

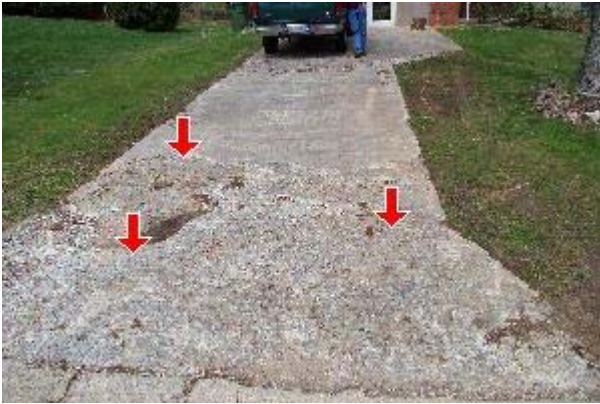
2.4 Picture 1

2.4 The concrete drive at the front of home are deteriorated in areas. A general replacement is likely. A qualified contractor should inspect and repair as needed.

The concrete drive at the front of home are deteriorated in areas. A general replacement is likely. A qualified contractor should inspect and repair as needed.

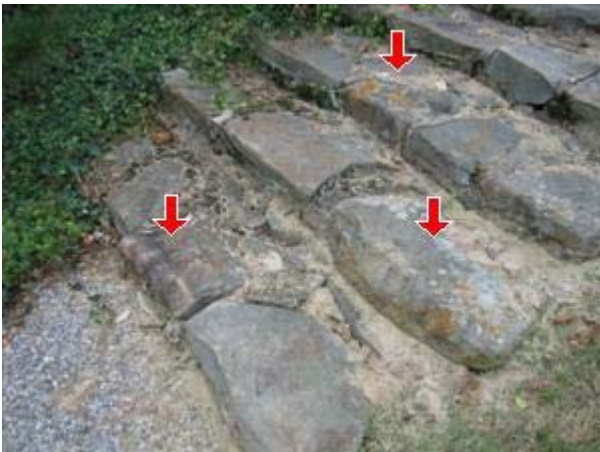
2.4 Picture 2

The rock steps at the front of home and rear of home are loose in areas. Water can cause further deterioration if not repaired and sealed properly. A qualified contractor should inspect and repair as needed.

The rock steps at the front of home and rear of home are loose in areas. Water can cause further deterioration if not repaired and sealed properly. A qualified contractor should inspect and repair as needed.

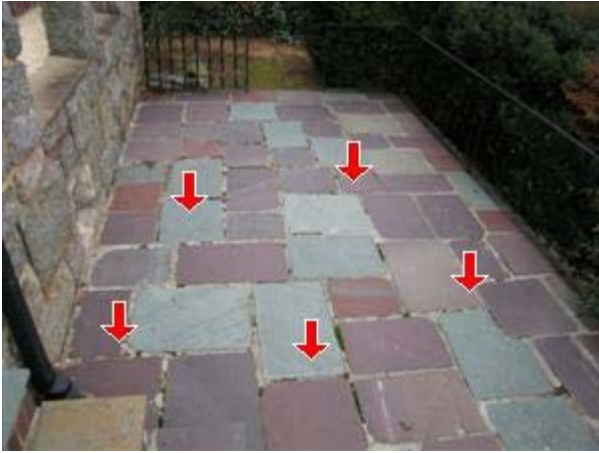
2.4 Picture 4

The slate floor on the patio at the front of home has deteriorated mortar or grout, and is loose and uneven in areas. A general replacement is likely. A qualified contractor should inspect and repair as needed.

The slate floor on the patio at the front of home has deteriorated mortar or grout, and is loose and uneven in areas. A general replacement is likely. A qualified contractor should inspect and repair as needed.

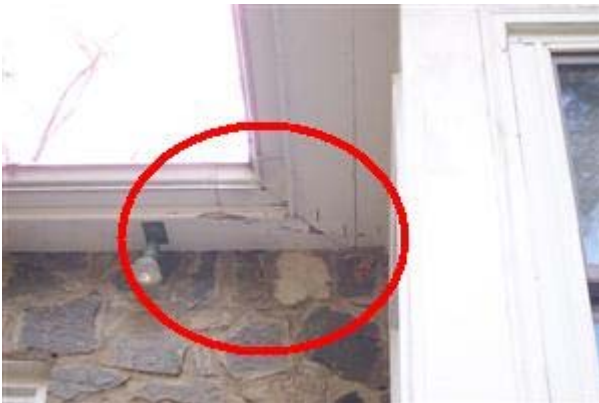
2.5 Picture 1

2.5 The soffit panel at eave on the front of home are weathered and beginning to deteriorate and peeling paint. Further deterioration may occur if not repaired. A qualified contractor should inspect and repair as needed.

The soffit panel at eave on the front of home are weathered and beginning to deteriorate and peeling paint. Further deterioration may occur if not repaired. A qualified contractor should inspect and repair as needed.

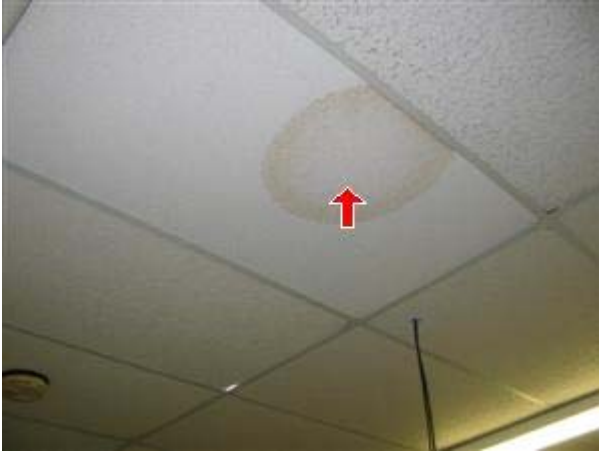
4.0 Picture 1

4.0 The Ceiling Tile on the ceiling reveals a water stain indicating a leak did or still exists at the Kitchen. Repairs are needed. A qualified contractor should inspect and repair as needed.

The Ceiling Tile on the ceiling reveals a water stain indicating a leak did or still exists at the Kitchen. Repairs are needed. A qualified contractor should inspect and repair as needed.

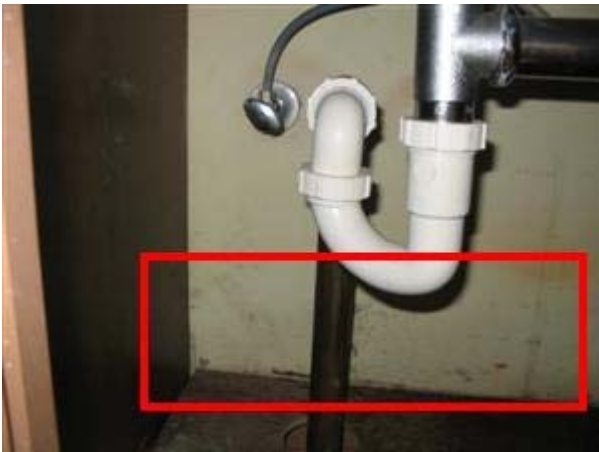
4.1 Picture 1

4.1 Signs of fungi growth is present on the interior wall of kitchen cabinetry in several areas. We did not inspect, test or determine if this growth is or is not a health hazard. The underlying cause is moisture. I recommend you contact a mold inspector or expert for investigation or correction if needed.

Signs of fungi growth is present on the interior wall of kitchen cabinetry in several areas. We did not inspect, test or determine if this growth is or is not a health hazard. The underlying cause is moisture. I recommend you contact a mold inspector or expert for investigation or correction if needed.

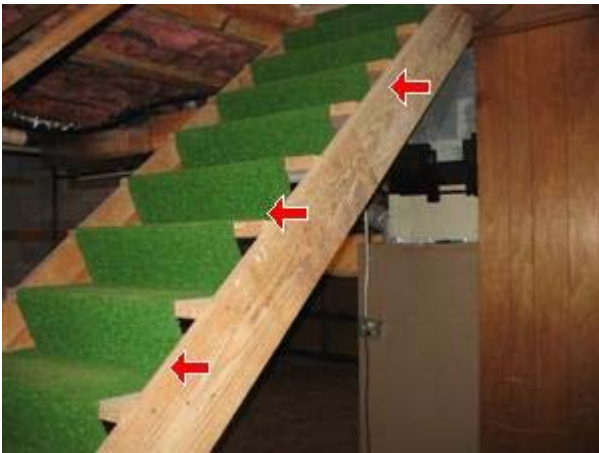
4.3 Picture 1

4.3 The hand/guard rail for the stairs to basement is missing and are missing pickets. Also the stringers are not built properly and treads are not supported properly. A fall or injury could occur if not corrected. A qualified contractor should repair or replace as needed.

The hand/guard rail for the stairs to basement is missing and are missing pickets. Also the stringers are not built properly and treads are not supported properly. A fall or injury could occur if not corrected. A qualified contractor should repair or replace as needed.

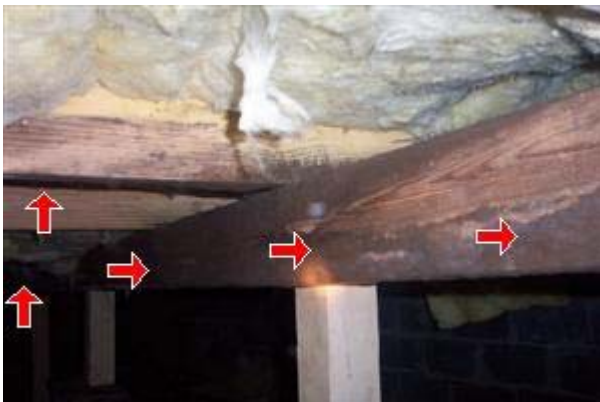
5.3 Picture 1

5.3 Signs of fungi growth is present on the floor system in crawlspace in several areas. We did not inspect, test or determine if this growth is or is not a health hazard. The underlying cause is moisture. I recommend you contact a mold inspector or expert for investigation or correction if needed.

Signs of fungi growth is present on the floor system in crawlspace in several areas. We did not inspect, test or determine if this growth is or is not a health hazard. The underlying cause is moisture. I recommend you contact a mold inspector or expert for investigation or correction if needed.

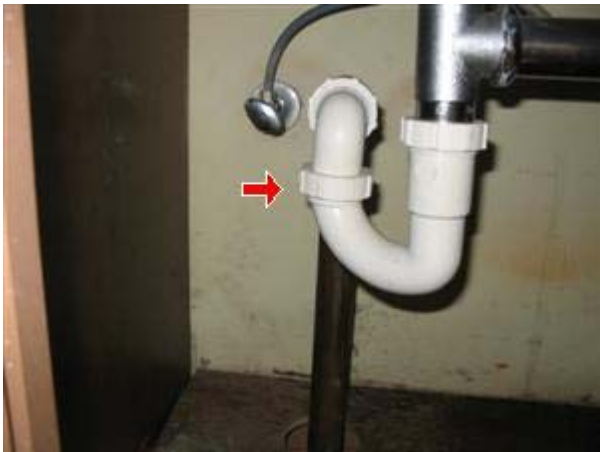
6.0 Picture 1

6.0 The waste line has a S-trap, and should be changed to a P-trap and "Auto-vent" at the Kitchen sink. This is not considered up to today's standard. A qualified licensed plumber should repair or correct as needed.

The waste line has a S-trap, and should be changed to a P-trap and "Auto-vent" at the Kitchen sink. This is not considered up to today's standard. A qualified licensed plumber should repair or correct as needed.

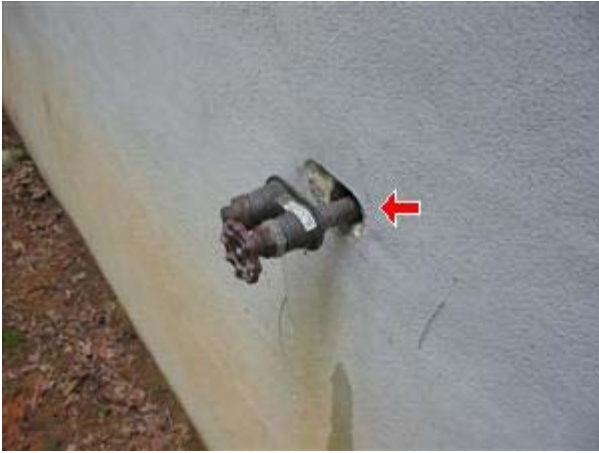
6.1 Picture 1

6.1 The outside water faucets are loose, and needs securing to wall and leaks when turned on and leaks at vacuum breaker at the left side (facing front) and right side (facing front). Repairs are needed. A qualified licensed plumber should repair or correct as needed.

The outside water faucets are loose, and needs securing to wall and leaks when turned on and leaks at vacuum breaker at the left side (facing front) and right side (facing front). Repairs are needed. A qualified licensed plumber should repair or correct as needed.

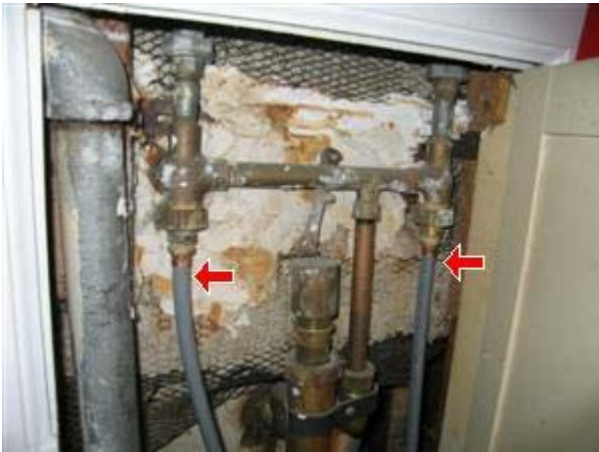
6.1 Picture 3

Polybutylene plastic plumbing supply lines (PB) are installed in the subject house. Polybutylene has been used in this area for many years, but has had a higher than normal failure rate, and is no longer being widely used. Copper and Brass fittings used in later years have apparently reduced the failure rate. This subject house has copper fittings. For further details contact the Consumer Plumbing Recovery center at 1-800-392-7591 or the web at <http://www.pbpipeline.com>

Polybutylene plastic plumbing supply lines (PB) are installed in the subject house. Polybutylene has been used in this area for many years, but has had a higher than normal failure rate, and is no longer being widely used. Copper and Brass fittings used in later years have apparently reduced the failure rate. This subject house has copper fittings. For further details contact the Consumer Plumbing Recovery center at 1-800-392-7591 or the web at <http://www.pbpipe.com>

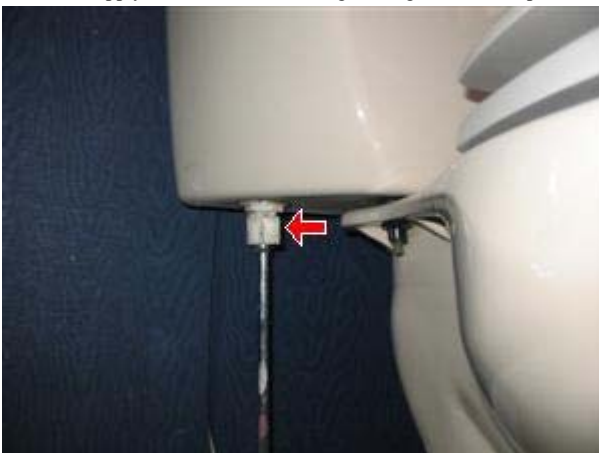
6.1 Picture 5

The water supply line for toilet is leaking at the guest bath. Repairs are needed. A qualified licensed plumber should repair or correct as needed.

The water supply line for toilet is leaking at the guest bath. Repairs are needed. A qualified licensed plumber should repair or correct as needed.

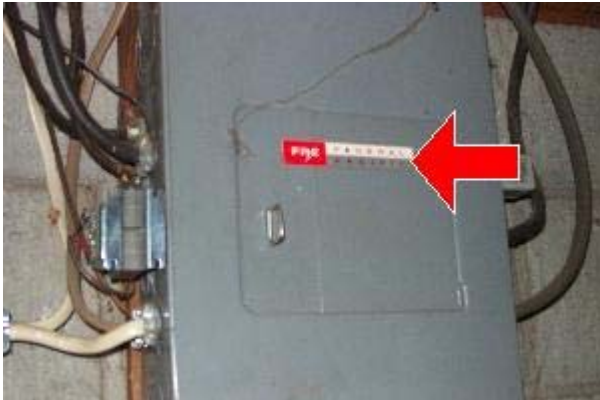
7.2 Picture 1

7.2 You have a Federal Pacific panel which is legal, but there is a possibility that the circuit breakers may not trip when shorted possibly causing an electrical hazard. Opinions by licensed electricians on this panel varies between safe and unsafe. I recommend you consult a licensed electrician for an opinion and correct if necessary.

You have a Federal Pacific panel which is legal, but there is a possibility that the circuit breakers may not trip when shorted possibly causing an electrical hazard. Opinions by licensed electricians on this panel varies between safe and unsafe. I recommend you consult a licensed electrician for an opinion and correct if necessary.

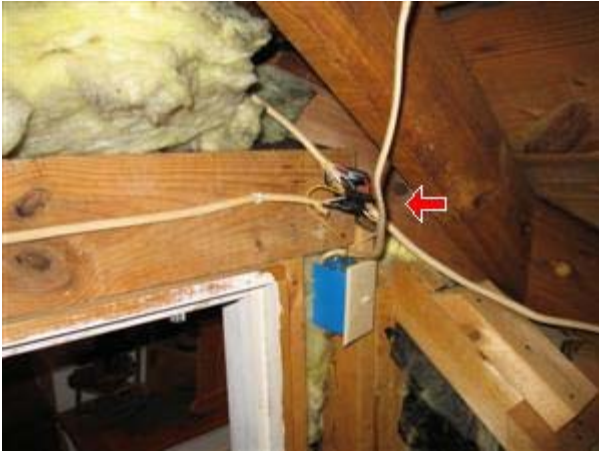
7.3 Picture 1

7.3 One loose wire splice and One loose wire end need placing in boxes with cover-plates within "Five feet" of attic access and above the Guest bath in attic. Electrical issues are considered a hazard until repaired. I recommend a qualified licensed electrician correct.

One loose wire splice and One loose wire end need placing in boxes with cover-plates within "Five feet" of attic access and above the Guest bath in attic. Electrical issues are considered a hazard until repaired. I recommend a qualified licensed electrician correct.

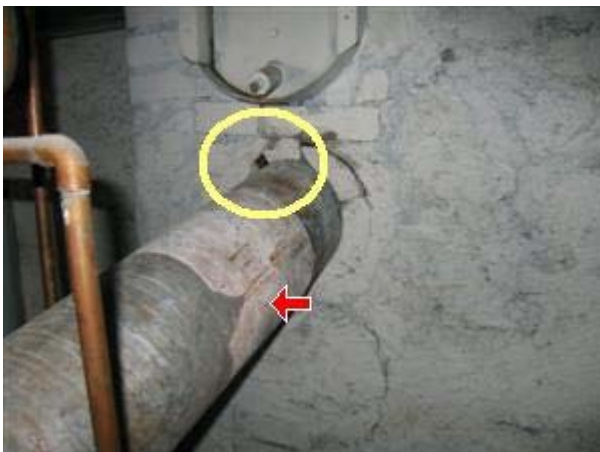
8.5 Picture 1

The vent pipe for oil fired boiler needs mastic sealed around pipe where it enters chimney. There is also a possibility of asbestos on the vent pipe. This is a safety issue and should be repaired. I recommend a qualified licensed heat contractor inspect further and repair as needed.

The vent pipe for oil fired boiler needs mastic sealed around pipe where it enters chimney. There is also a possibility of asbestos on the vent pipe. This is a safety issue and should be repaired. I recommend a qualified licensed heat contractor inspect further and repair as needed.

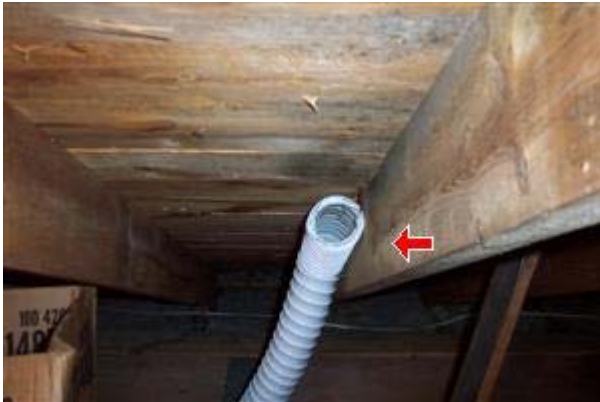
9.4 Picture 1

9.4 The Exhaust fan does not vent to outside at the guest bath. Vent pipes should terminate outside and not in the attic. Many homes have their vent pipe poised at the roof vent such as yours. It is up to you to determine whether or not this is a concern or needs further consideration from a general contractor. A qualified contractor should inspect and repair as needed.

The Exhaust fan does not vent to outside at the guest bath. Vent pipes should terminate outside and not in the attic. Many homes have their vent pipe poised at the roof vent such as yours. It is up to you to determine whether or not this is a concern or needs further consideration from a general contractor. A qualified contractor should inspect and repair as needed.
